**THE CALIFORNIA EARTHQUAKE OF APRIL 18, 1906**

**REPORT**

**STATE EARTHQUAKE INVESTIGATION COMMISSION**

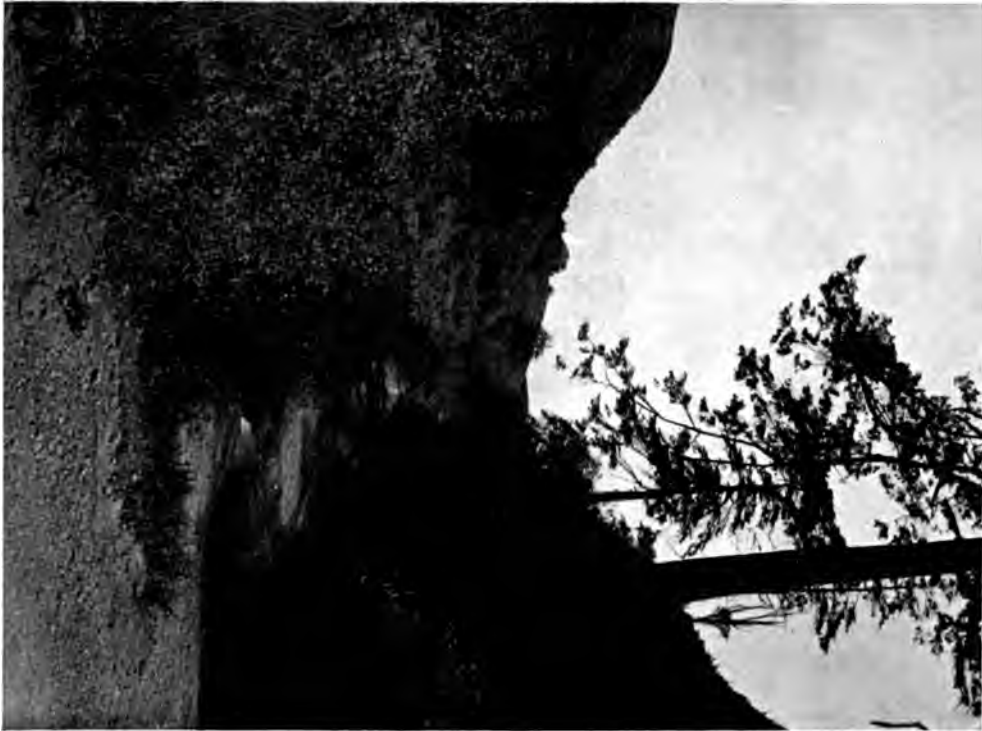
A. Wood Gulch, Humboldt County. The Rift near its northern end. A. S. E.

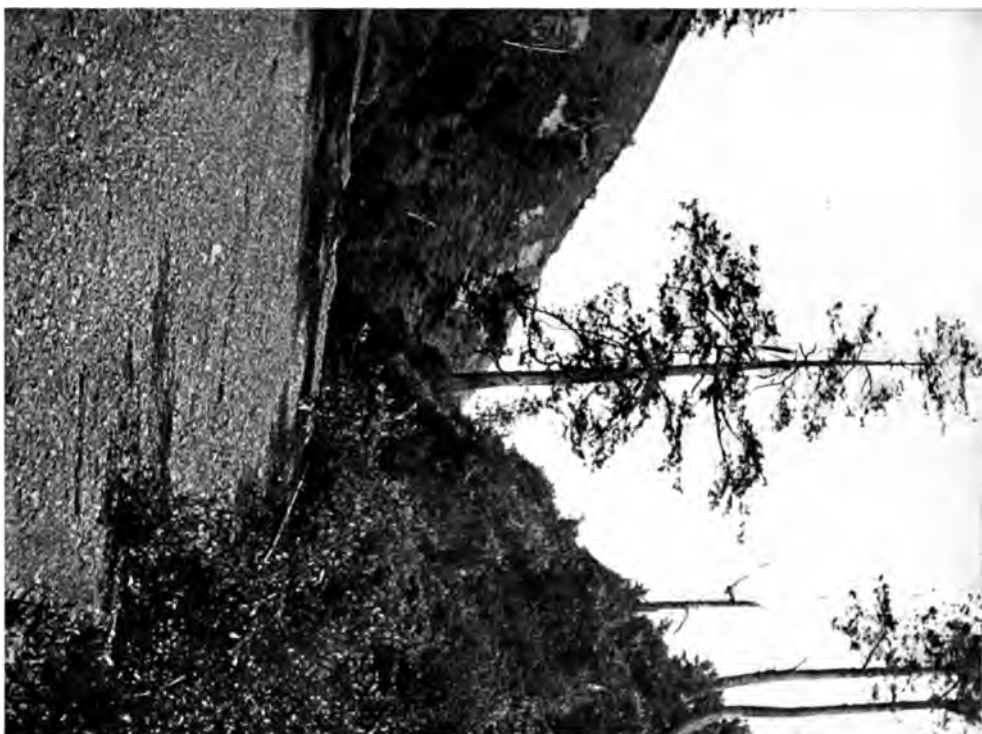
B. Another view of the Rift. Wood Gulch. A. S. E.

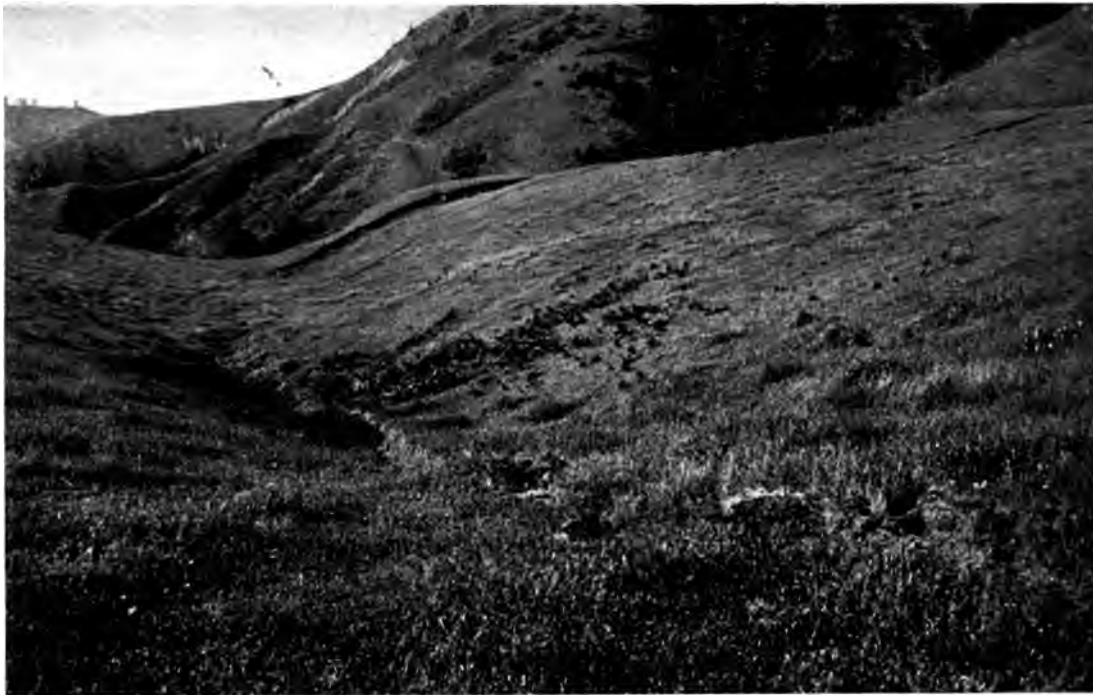
A. The Rift above Shelter Cove, Humboldt County. A. S. E.

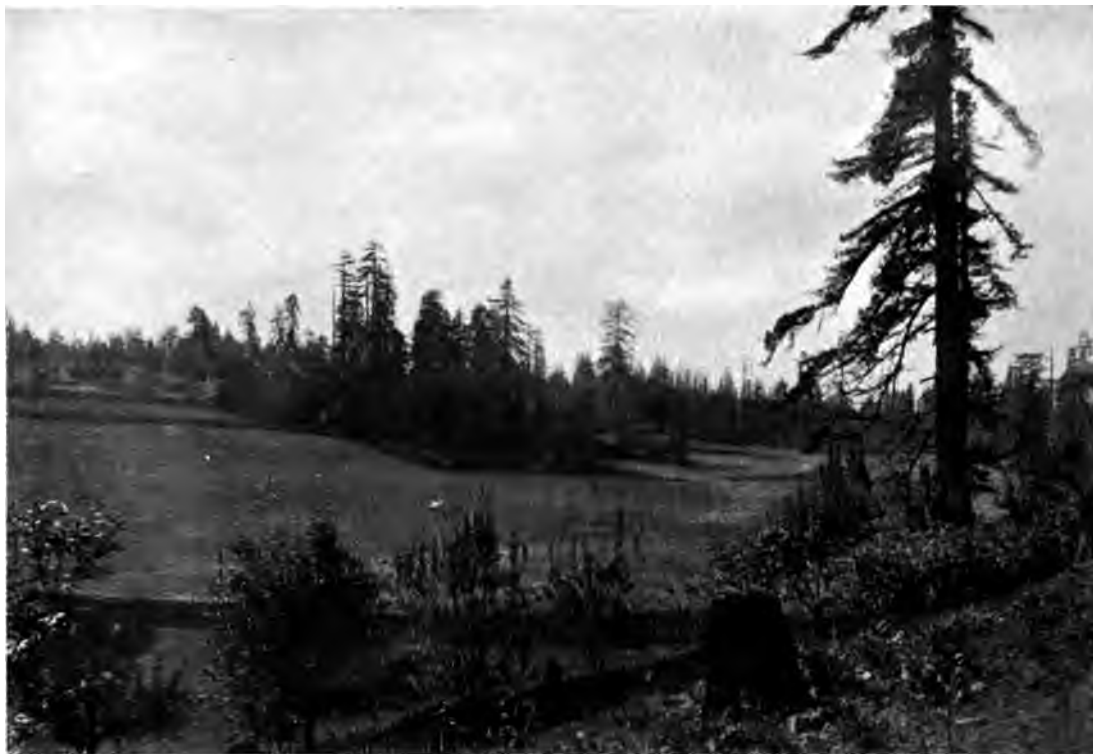
B. The Rift on the divide between the upper Gualala and the coast north of Fort Ross. H. W. F.

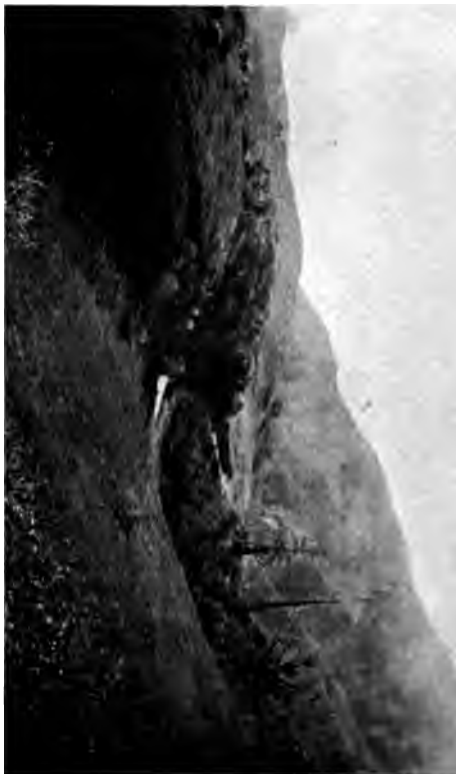
A. The Rift above Shelter Cove, looking northwest. The fault-trace follows old diastrophic features. F. E. M.

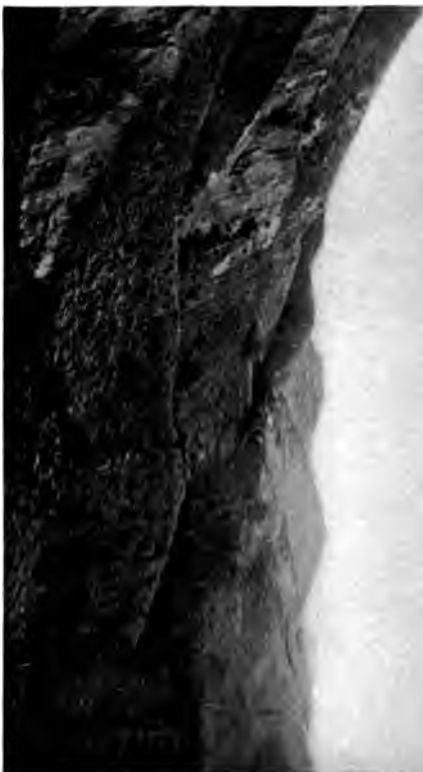
B. Northeast of Shelter Cove. Rift in the middle ground. F. E. M.

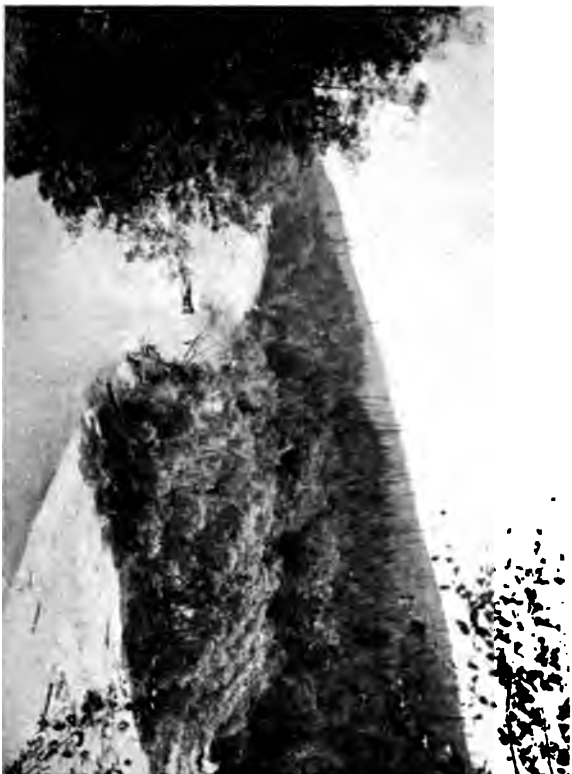
C. Looking up Garcia River along the Rift. F. E. M.

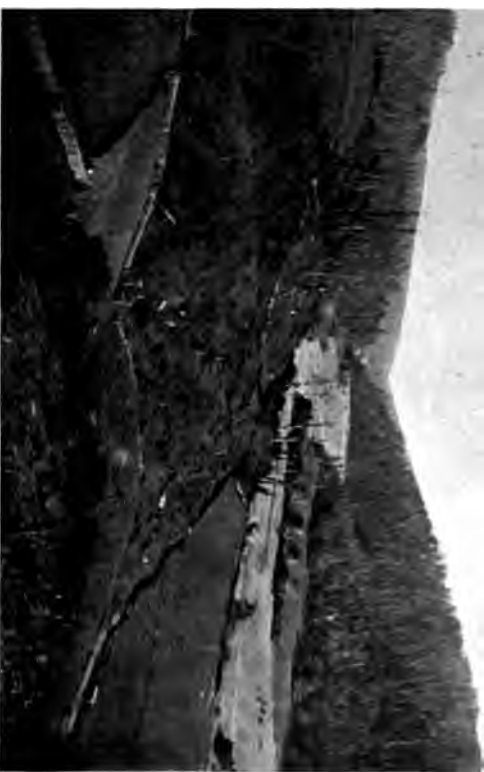
D. Looking up Garcia River along the Rift. F. E. M.

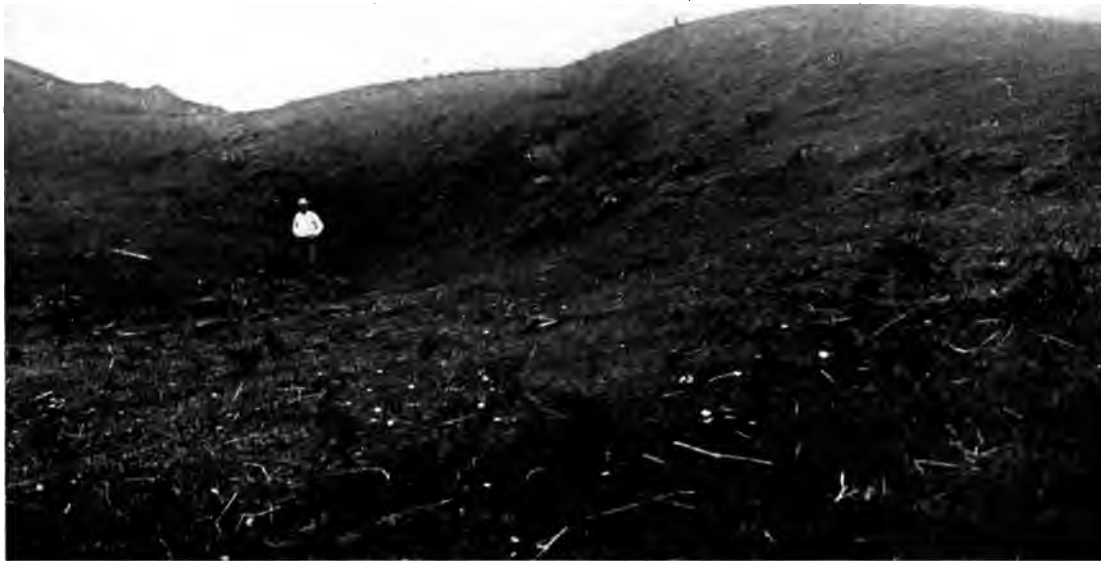
A. Characteristic Rift features southeast of Fort Ross. Figure on fault-trace. A. C. L.

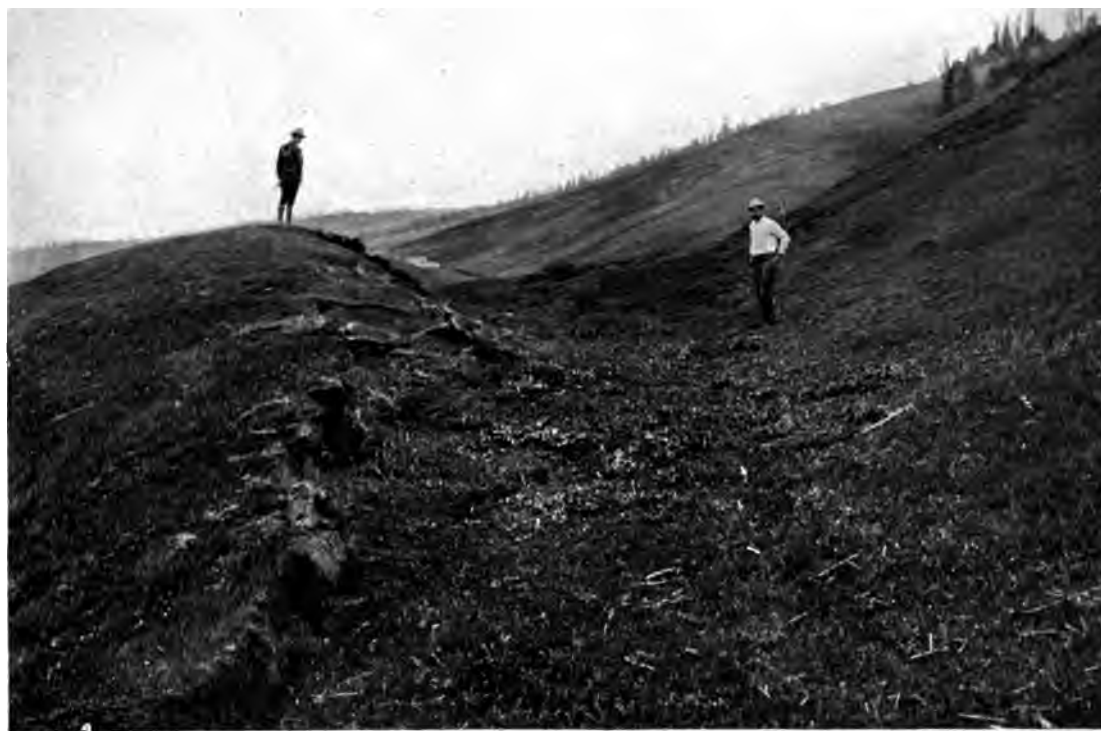
B. Characteristic Rift features southeast of Fort Ross. Fault-trace in foreground. A. C. L.

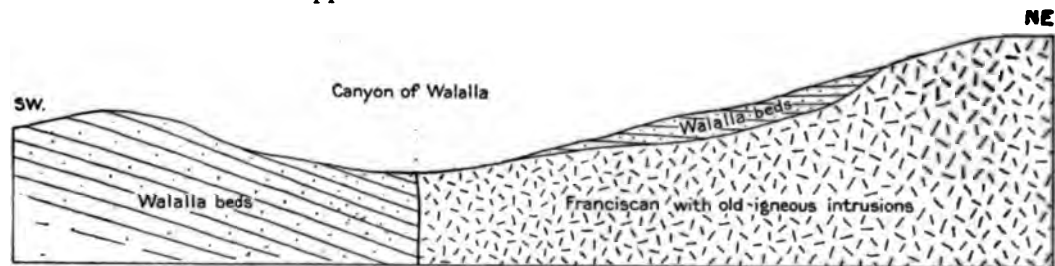
FIG. 1. — Geological section transverse to the Rift where it is followed by the Walalla (Gualala) River.

At the point where the road from Stewarts to Geyserville crosses the Gualala River, faulting and erosion have exposed the underlying Franciscan formation. This appears upon the northeast side, showing that the opposite side, that toward the ocean, has dropt. The Franciscan occupies but a narrow strip and is replaced for some distance up the ridge upon the northeast, by Walalla sandstones. These relations are shown in the cross-section sketch shown in fig. 1. Near the mouth of the Walalla River the formation upon the coast side of the Rift still appears to be the Walalla sandstones; the rocks upon the opposite side are buried under the alluvium of the valley. After leaving the valley of the Garcia River, the Rift lies wholly within the Franciscan formation until it disappears in the ocean. The Monterey shales with sandstones at their base form nearly the whole of the coastal terraced plain in the vicinity of Point Arena. They rest unconformably upon the Franciscan rocks and dip at a steep angle to the southwest. The Monterey formation nowhere appears to come in contact with the fault.

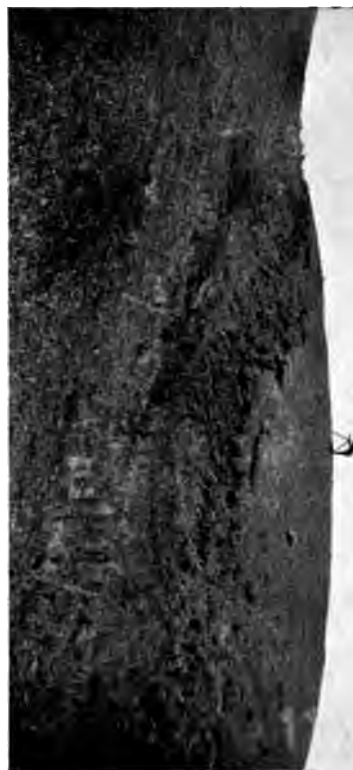
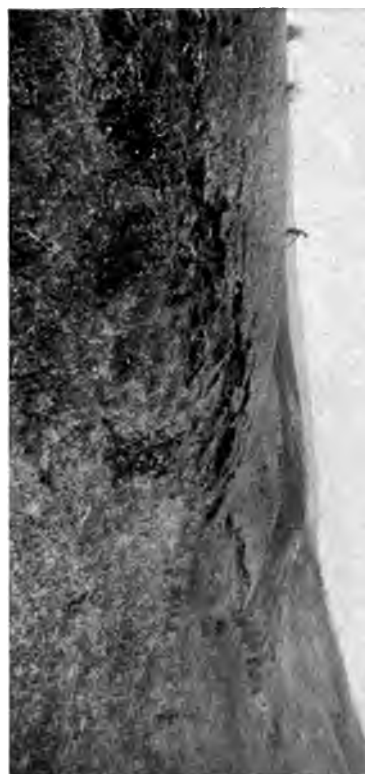
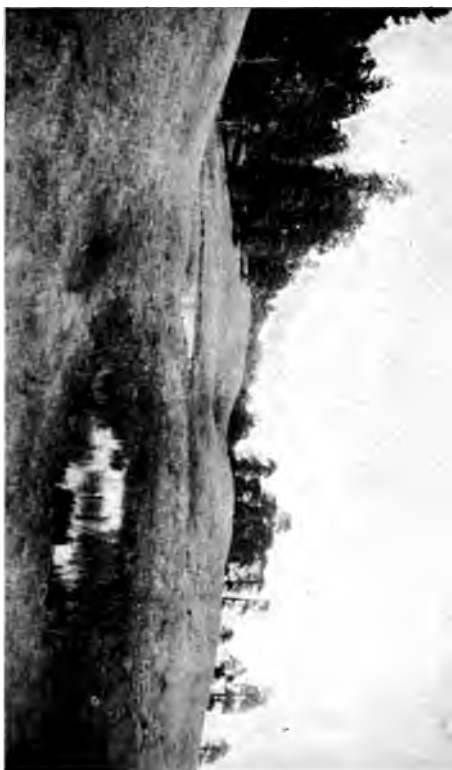
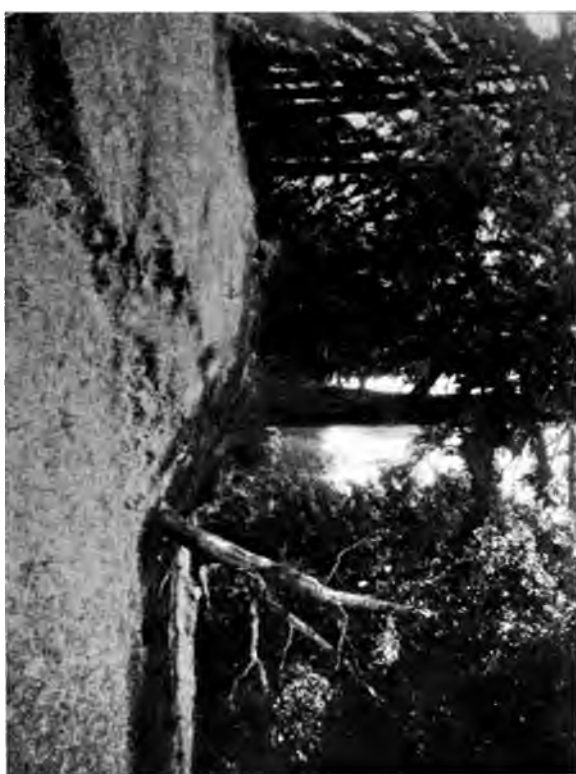
Characteristic lift features near Fort Ross. Old scars accentuated by new fault. Undrained ponds. F. E. M.

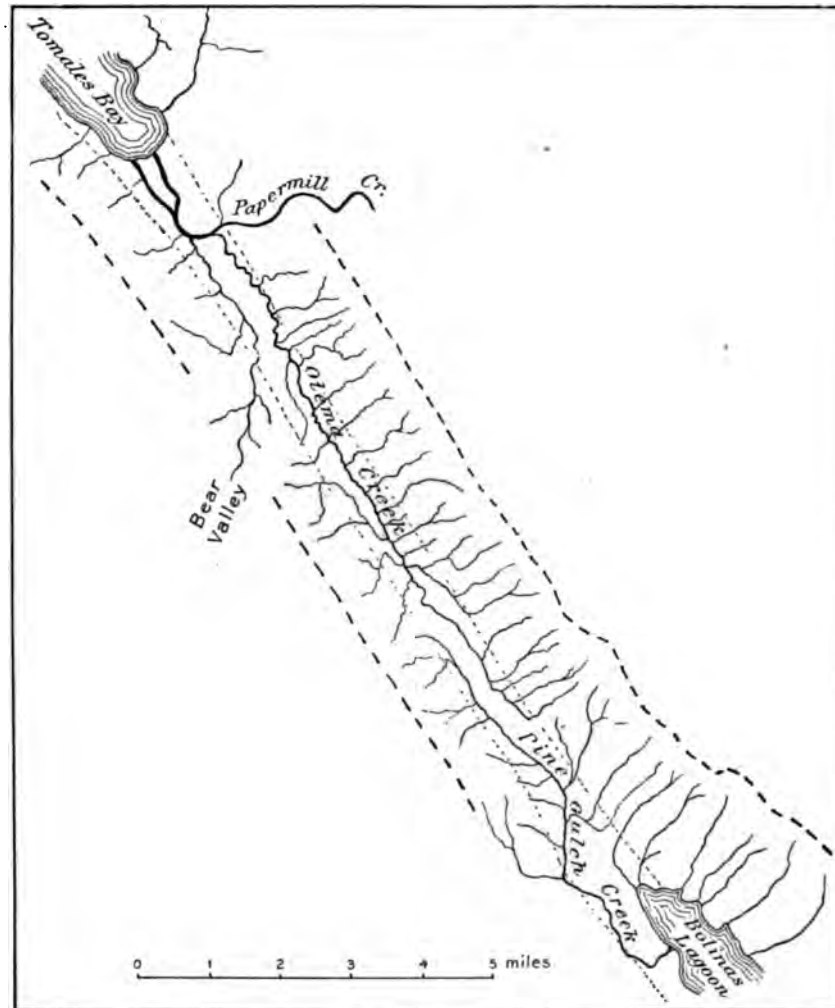
The influence of the ridges on the drainage is illustrated by the accompanying diagrams. Fig. 2 shows the actual drainage system; fig. 3 the system which would be developed if there were no special conditions along the axial zone. The small ridges of the axial zone trend parallel to the axis, and their interference gives parallel courses to various streams which would otherwise unite. The influence of the drainage on the ridges is illustrated by fig. 4, which shows a small ridge resting on the side slope of a larger ridge. The drainage of the larger ridge breaks thru the smaller, making gaps. Plate 7B shows the slope of a greater ridge at the right; and at the left two bushy hills

FIG. 2.—Drainage map of Bolinas-Tomaes Valley. Heavy broken lines show crests of bounding ridges. Light broken lines indicate limits of Rift topography.

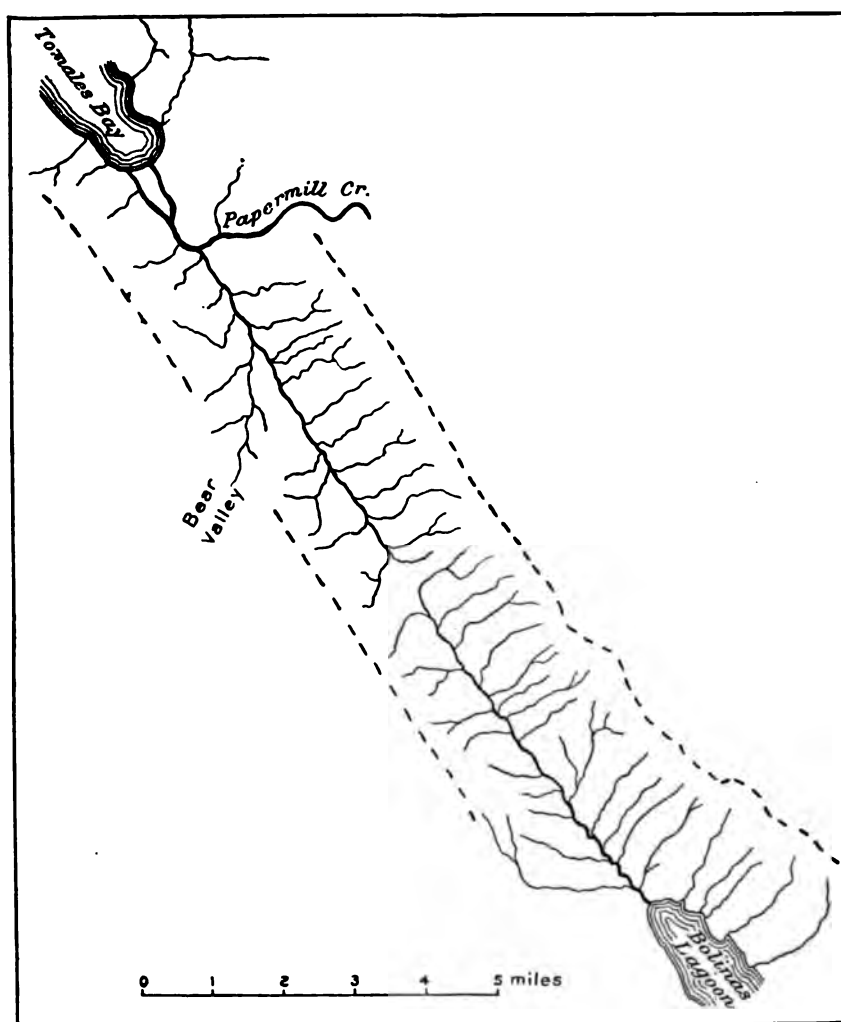
FIG. 3.—Hypothetic drainage map of Bolinas-Tomales Valley, if developed without influence of Rift displacement. Compare fig. 2.

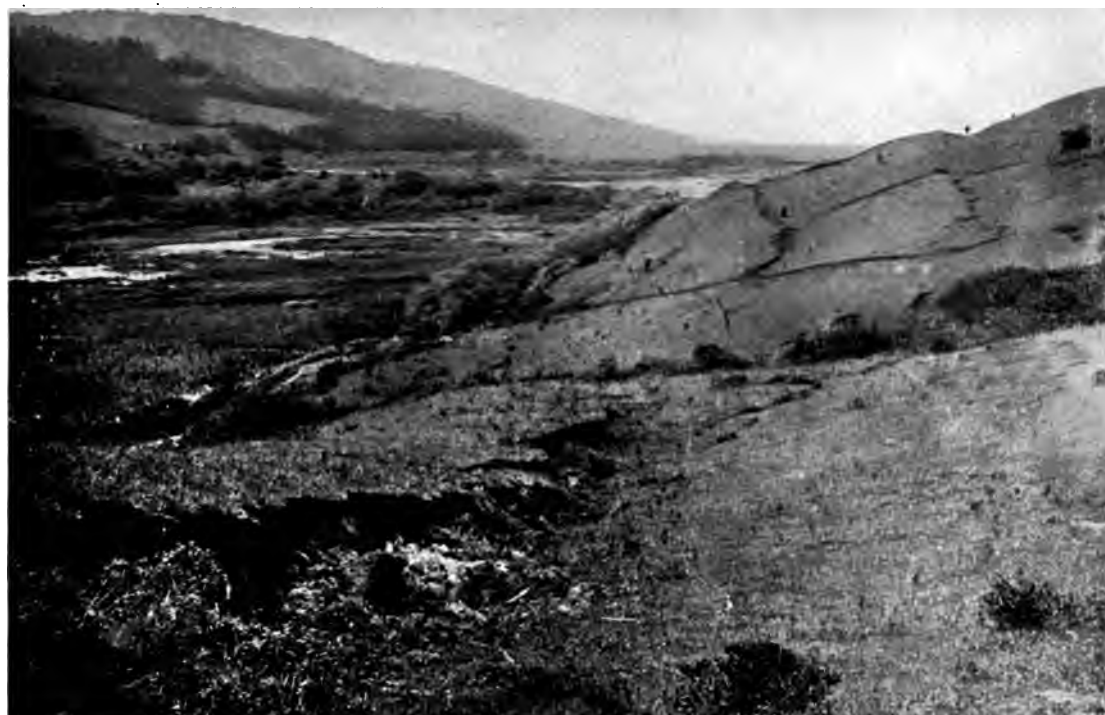
A. Looking down Tomales Bay from near Olema. H. W. F.

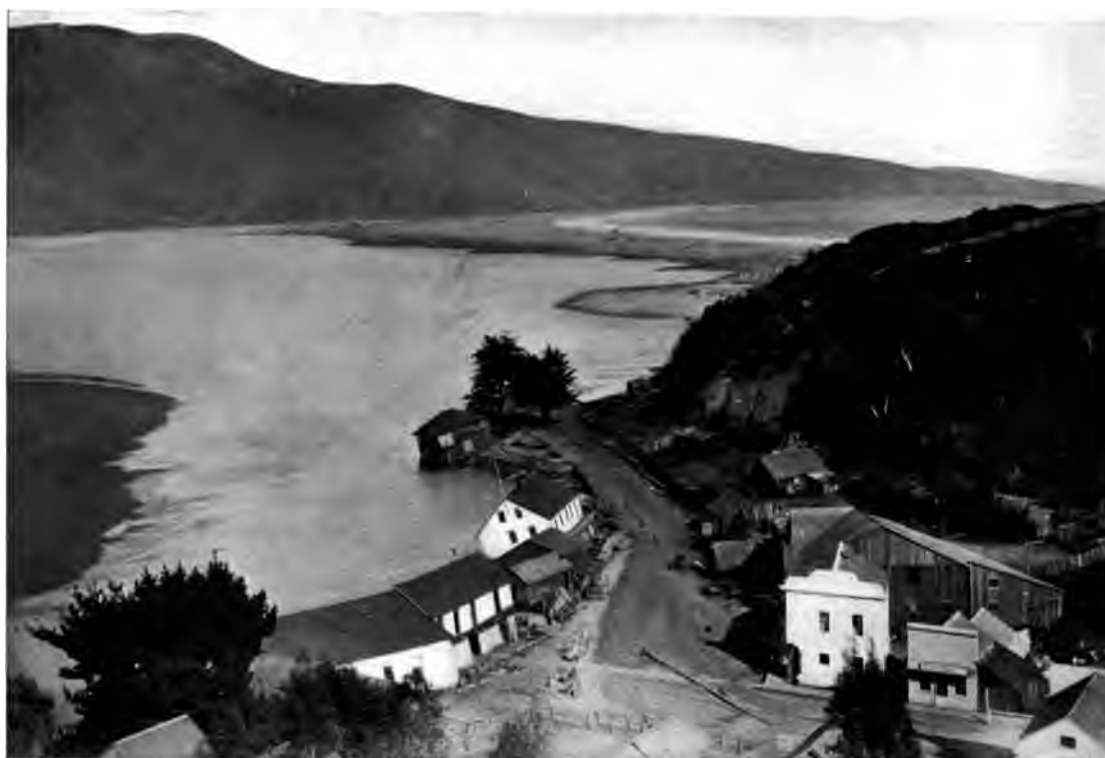
B. Looking down Bolinas Lagoon and Bay toward the Golden Gate. Village of Bolinas in foreground. H. W. F.

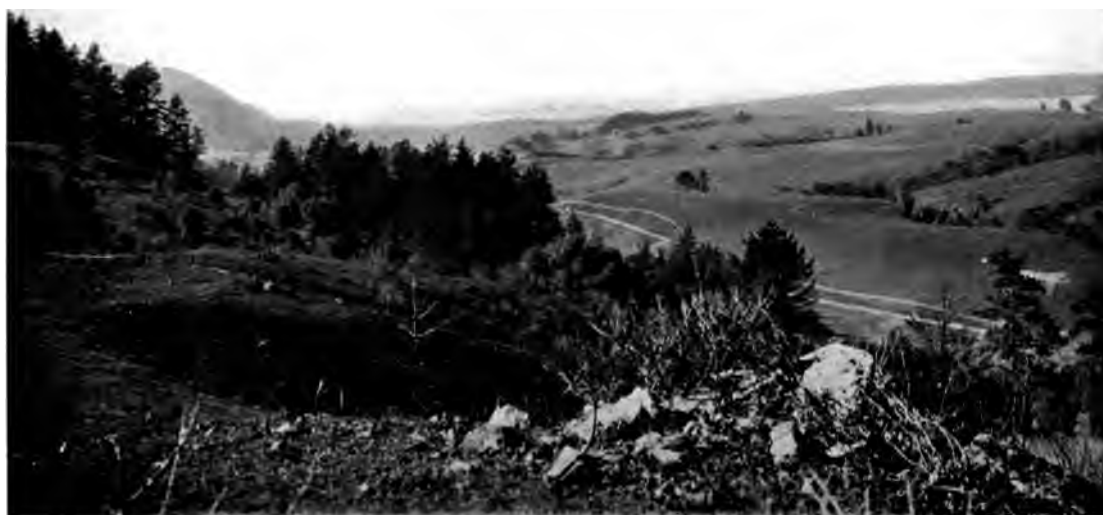
A. Looking north in the Bolinas-Tomales Valley. G.K.G.

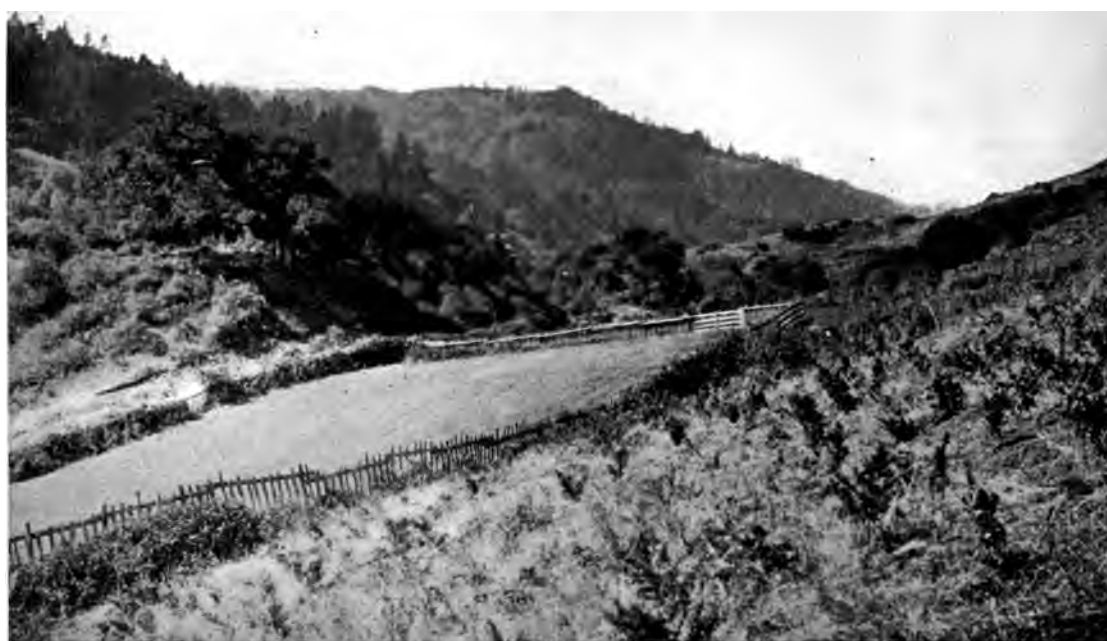
B. Fault-sag and side-hill ridge near Bondietti's ranch. The fault-trace follows sag and appears at left of field. G.K.G.

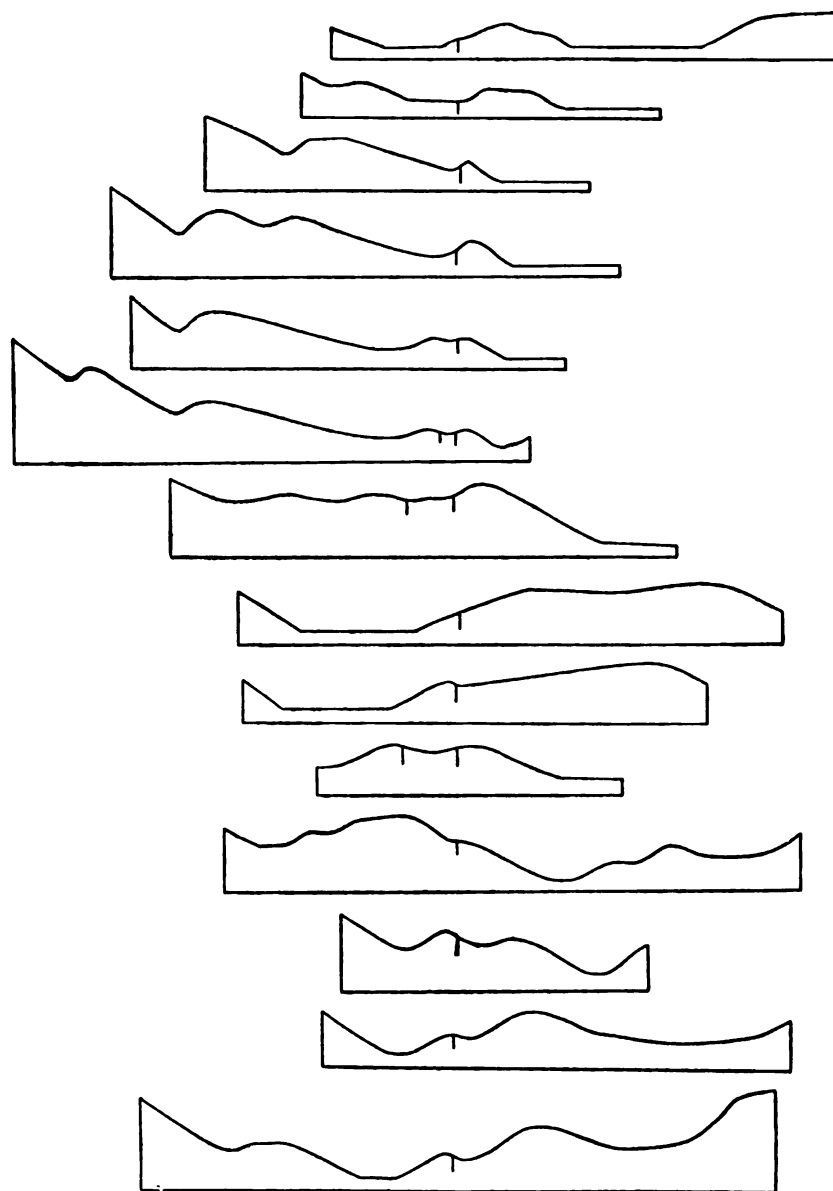
FIG. 9. — Cross-profiles of the Rift arranged in geographical order with the most northerly at top and northeast ends at the right. Positions of fault-trace and its branches are indicated. The profiles are copied from field sketches made without measurement.

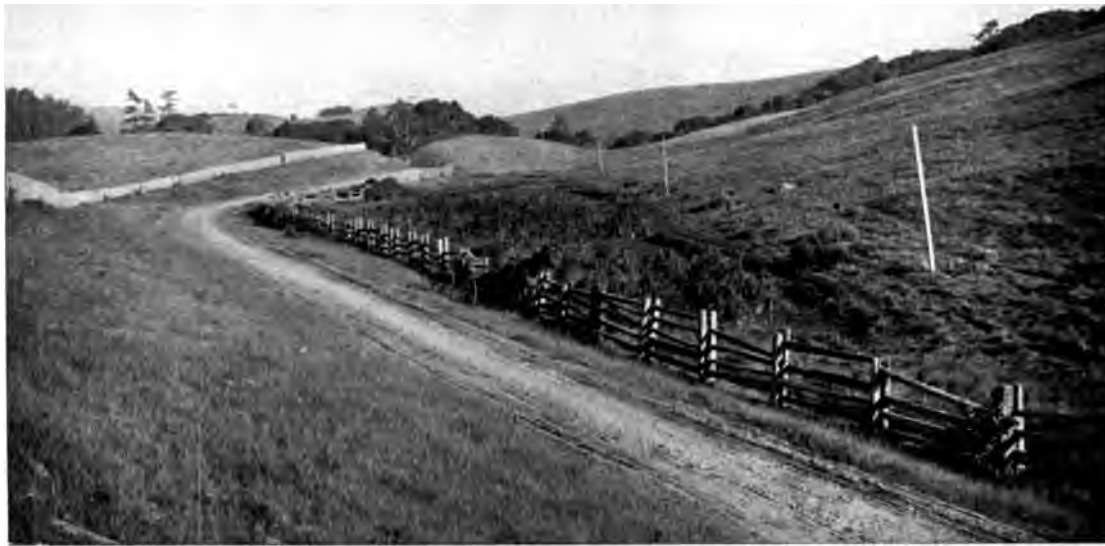
A. Fault-sag 6 miles south of Olema, looking northwest. The drainage crosses the sag from right to left. G.K.G.

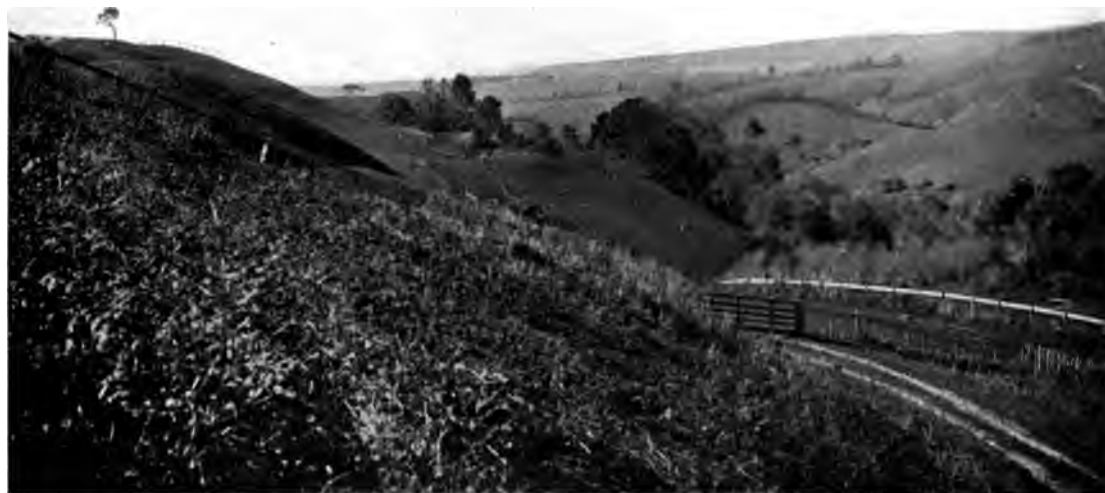
B. Side-hill ridge 4 miles south of Olema, looking northwest.

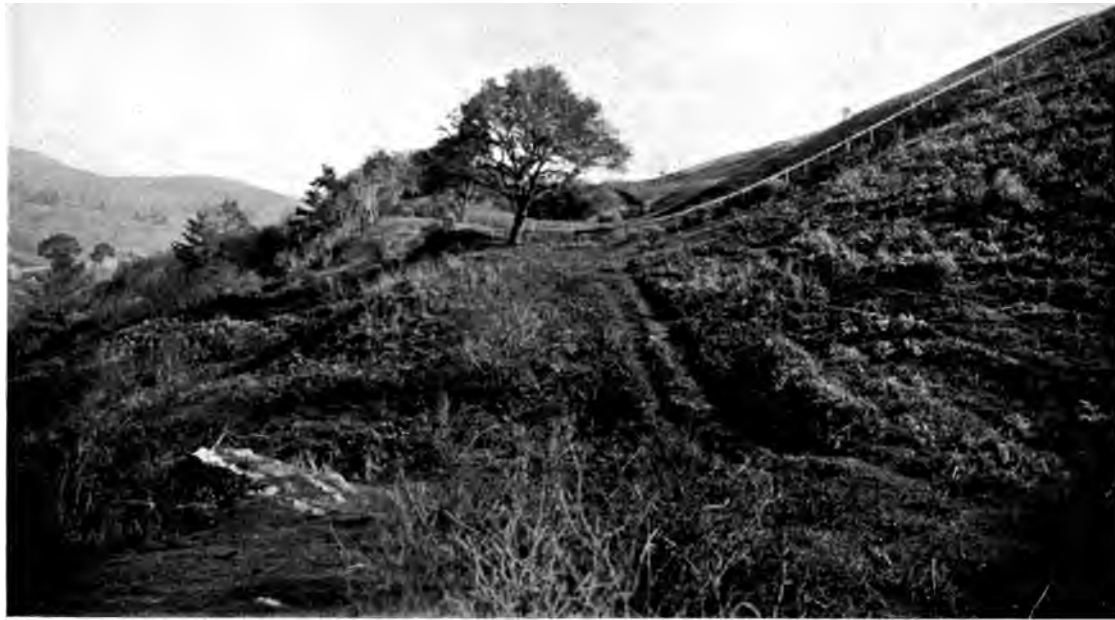
A. Side-hill ridge 4 miles south of Olema, looking southeast. G. K. G.

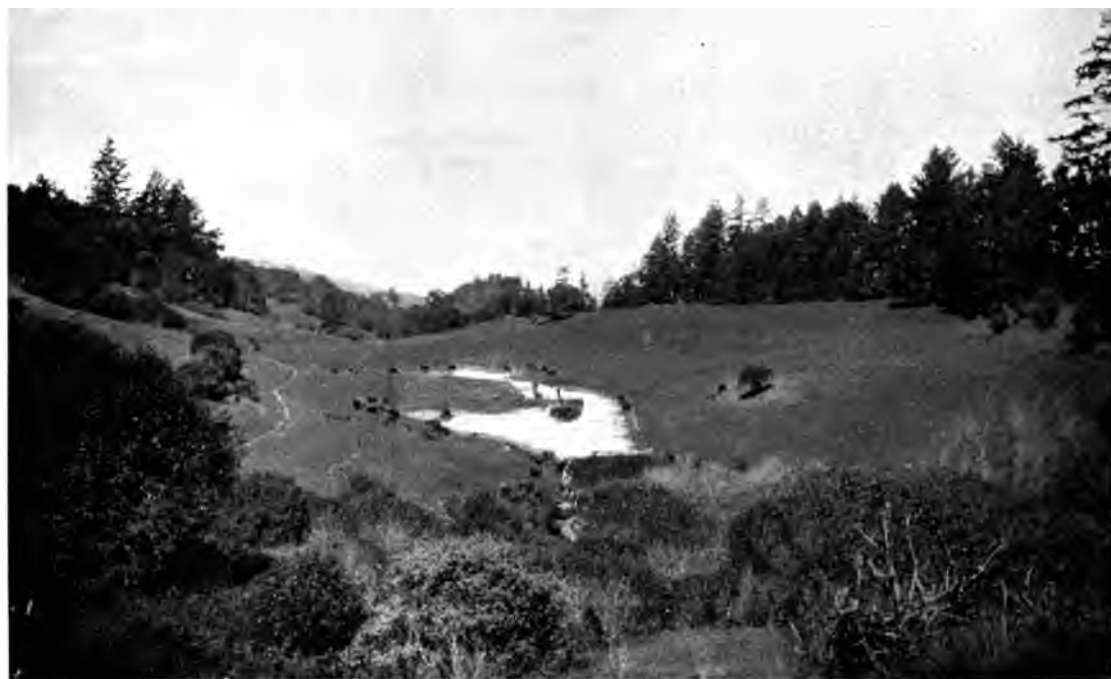
B. Rift topography, with pond, a mile south of Olema, looking southeast. G. K. G.

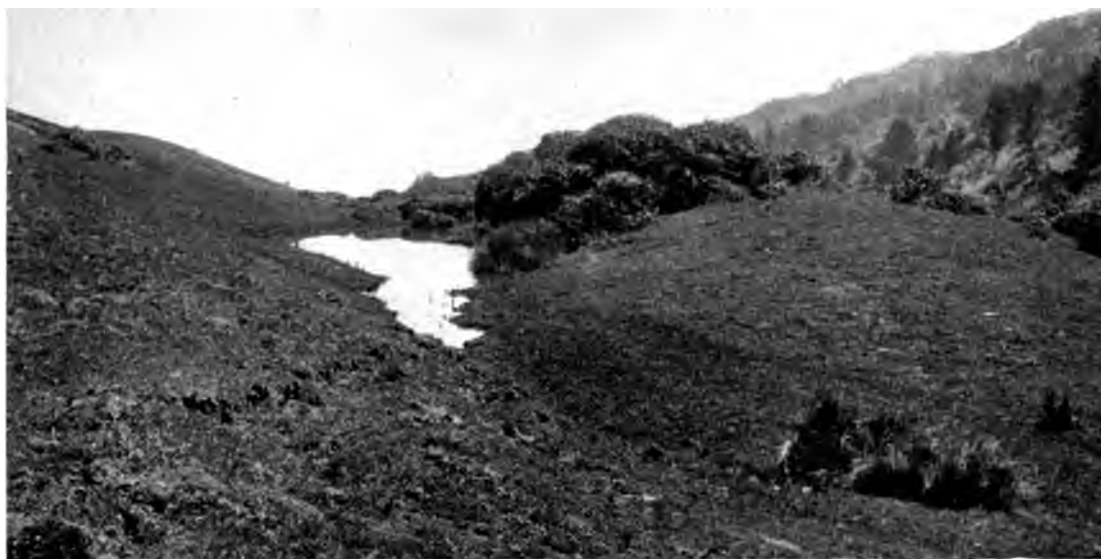
A. Rift topography, with pond, near Bondietti's ranch, looking southeast. G. K. G.

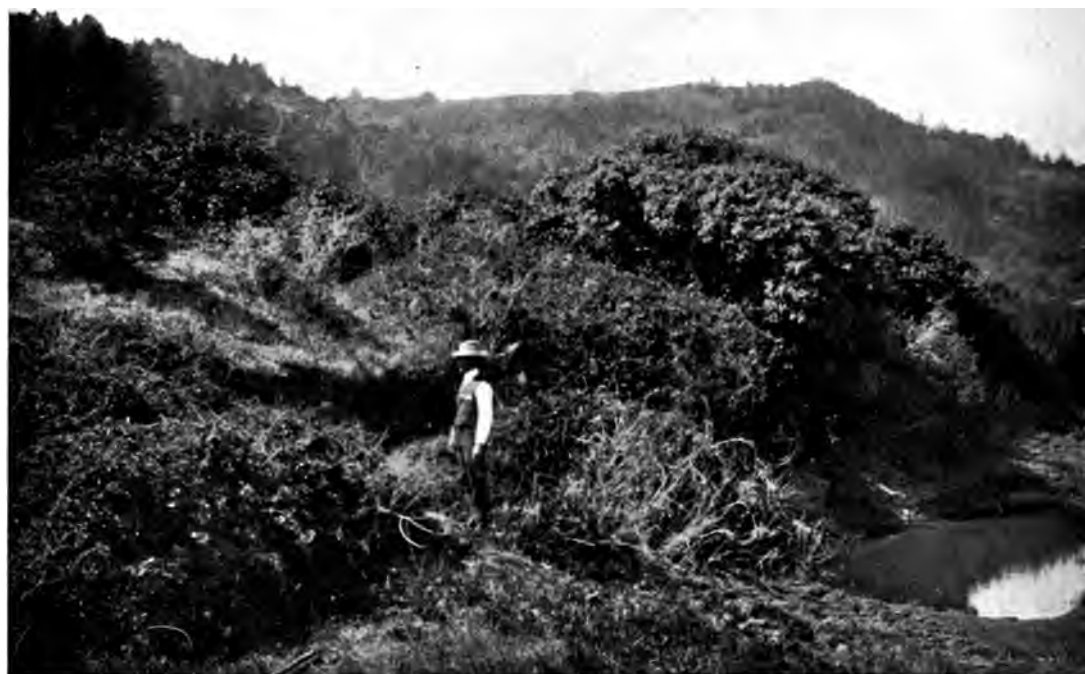
B. The fault-trace near Bondietti's ranch, looking west. Illustrates the association of vertical displacement with fault-sags and ponds. G. K. G.

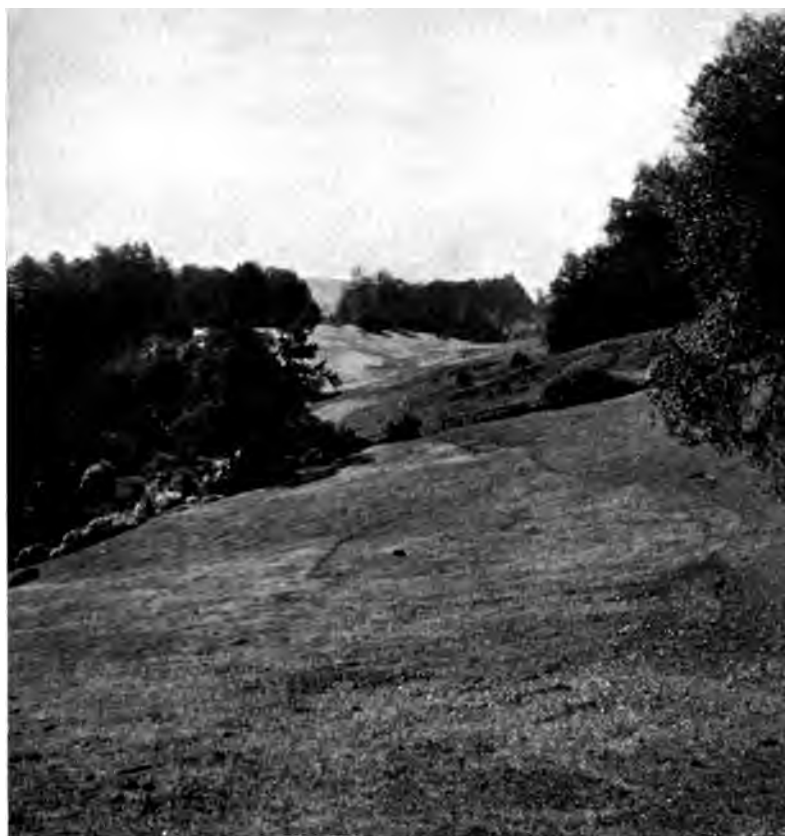
A. Fault-sag 2 miles south of Olema, looking southeast. G. K. G.

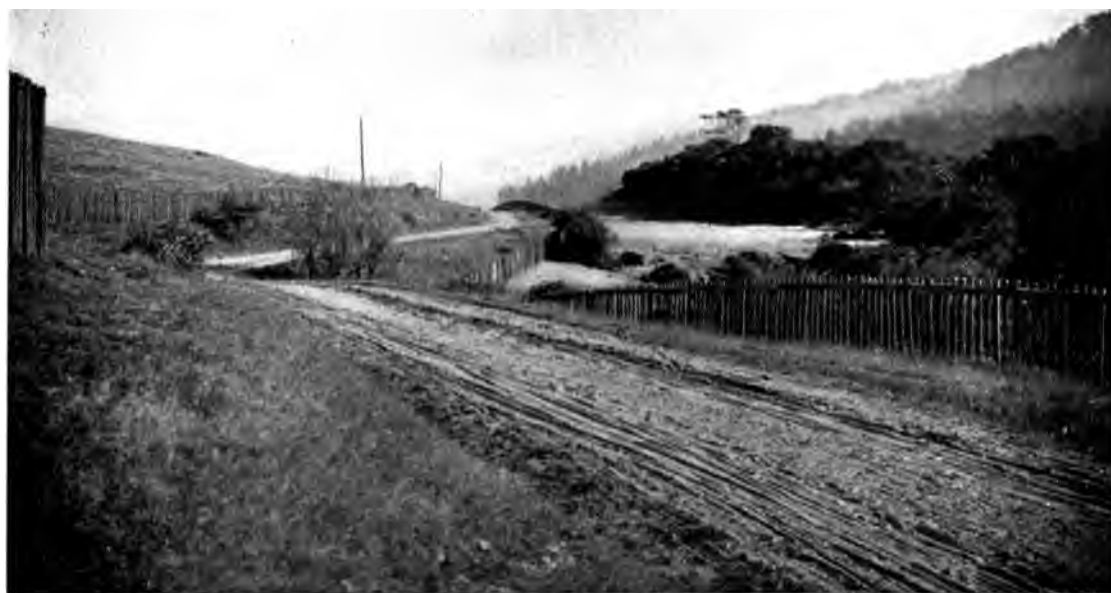
B. Fault-sag 3 miles south of Olema, looking southeast. G. K. G.

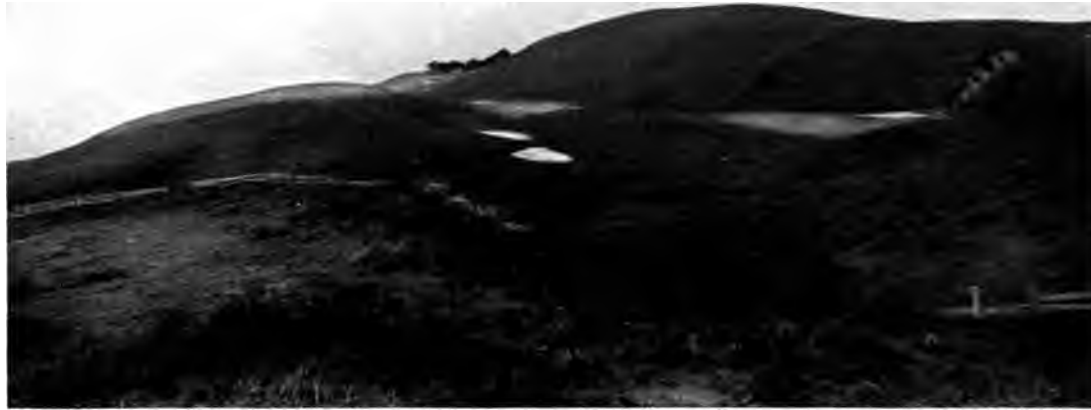
A. Great landslide at Mussel Rock, where the Rift enters the Coast from the Pacific. H. O. W.

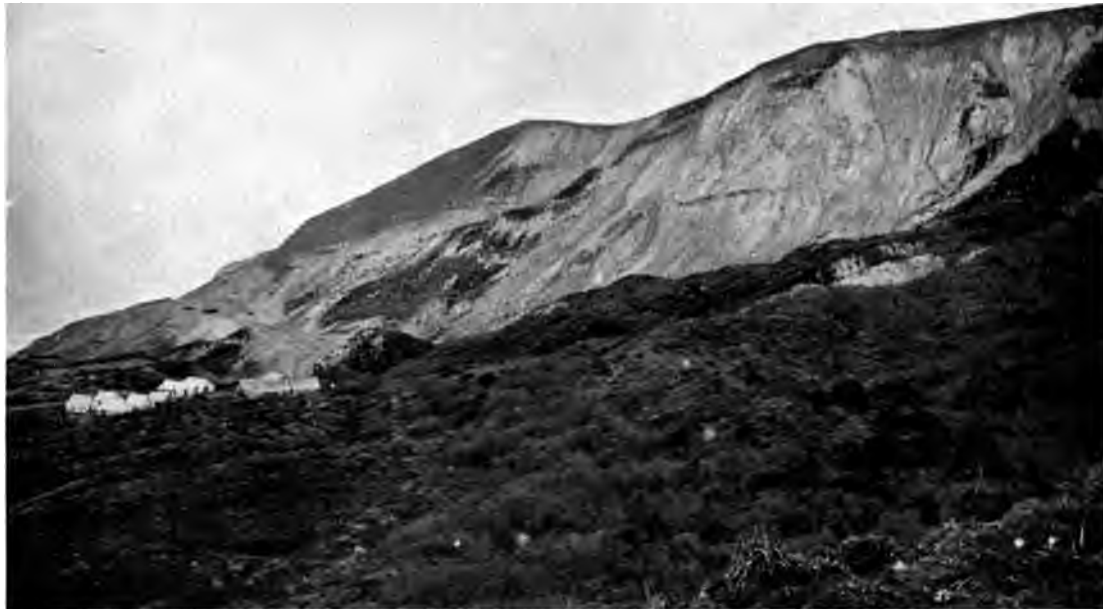
B. Looking northwest along the Rift. The landslide is just beyond the house. H. O. W.

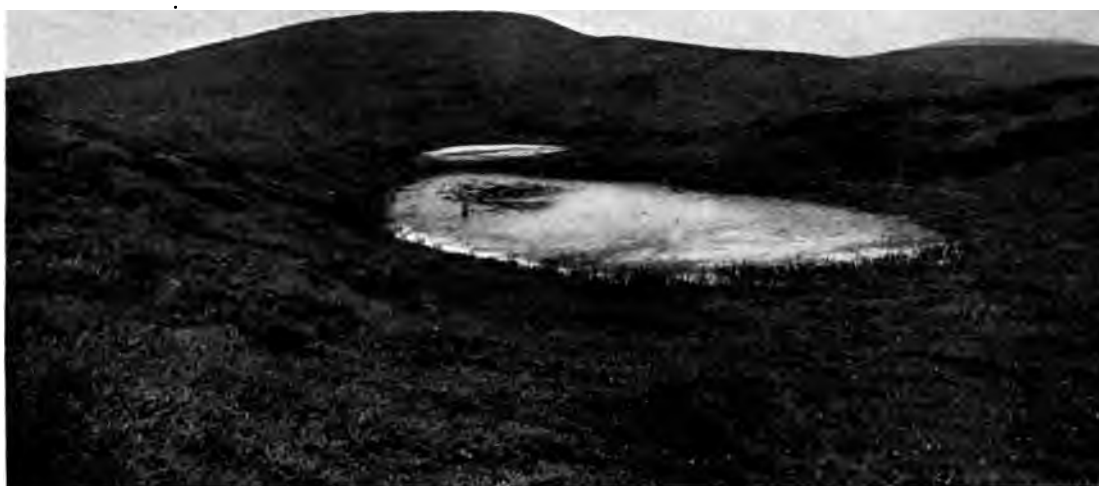
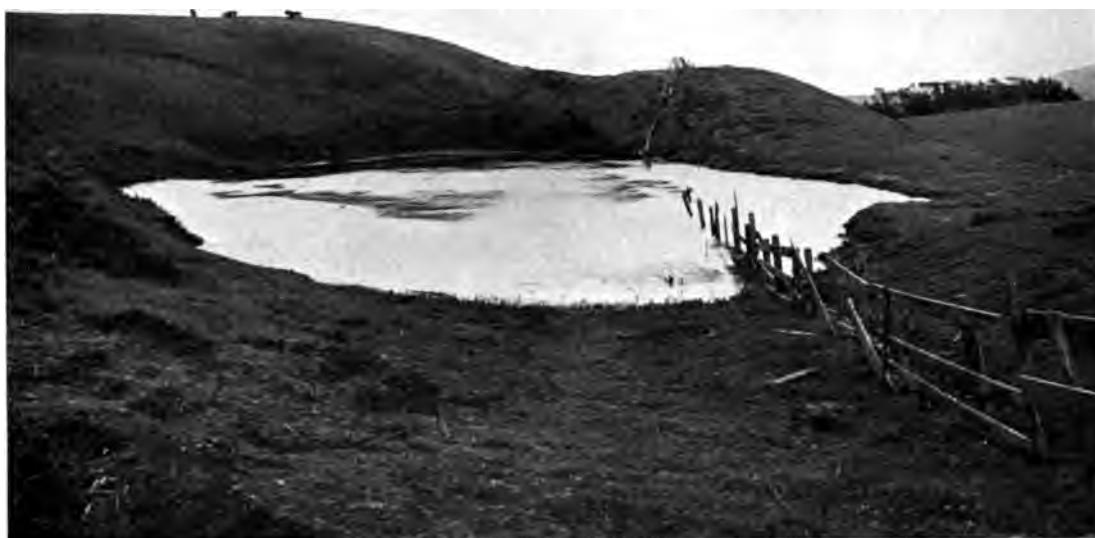
Characteristic ponds along the Rift southeast of Mussel Rock. H. O. W.

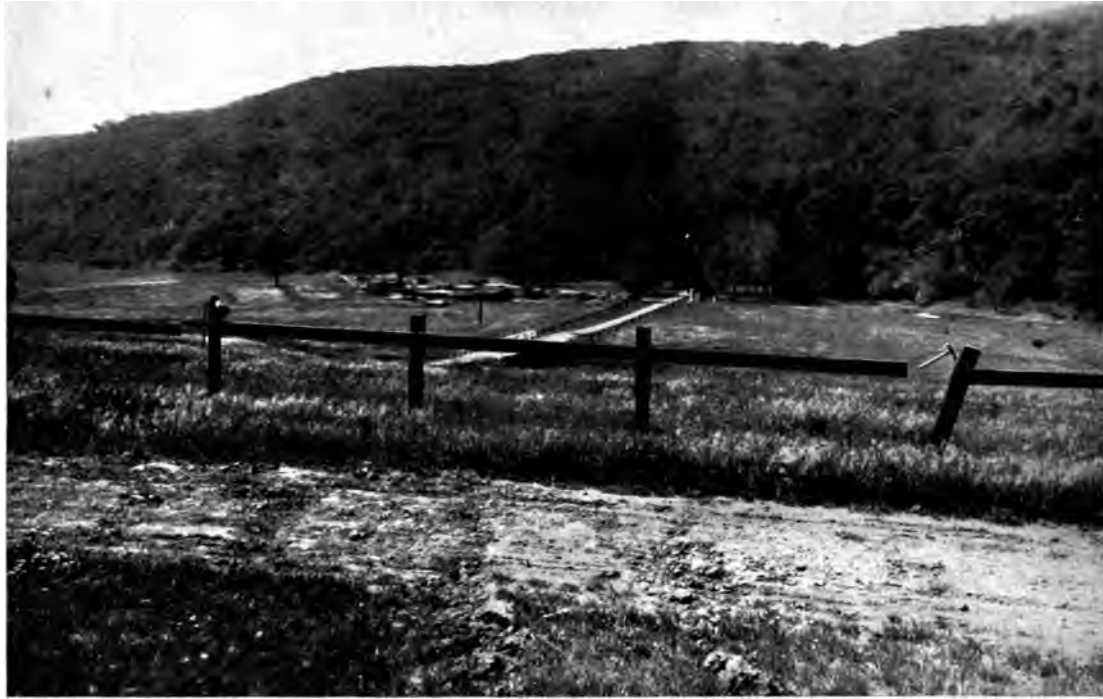
A. The Rift valley between San Andreas Lake and Crystal Springs, looking southwest. Fault-trace parallel to fence about 50 feet beyond. Auxiliary cracks in the foreground at an angle of  $40^\circ$  with it. J. O. B.
